## Analysis of Surface Degradation of Silicon Rubber Insulators after 30 Years in-Service

Lunnetta Safura Lumba and Suwarno

School of Electrical Engineering and Informatics  
Institut Teknologi Bandung  
Bandung, Indonesia

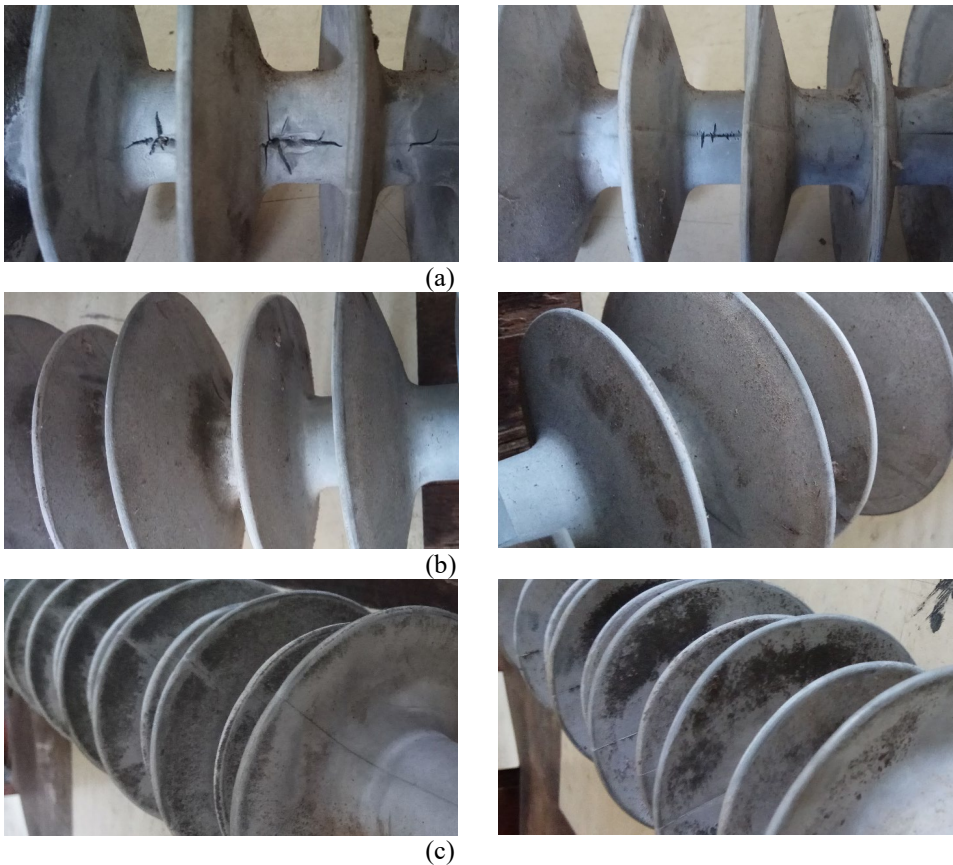
Figure 6. (a) Crack on Aged Insulator Sheath; (b) Upper View of Aged Insulator; (c) Bottom View of Aged Insulator (Left: Natural Aging-1 Sample, Right: Natural Aging-2 Sample)

As shown on figure 6, surface deterioration of the aged polymeric insulators was visible seen without any help from advanced tools. The most significant changes that were observed are as follows:

- White powder on surface and discoloration
- Contamination or dirt
- Silicone grease on one side
- Fungus contamination on the bottom side
- Sheath cracked and moisture penetration at some sheath points

The cracks were clearly seen on insulator sheath as illustrated on figure 6 (a). For the natural aging-1, it was observed that there were two crack points on the sheath. From left to right crack, that had 30 mm and 38 mm in length. While, for the natural aging-2, there was only one visible crack on the sheath with the length of 28 mm. This severe crack condition was probably due to continual activity of dry discharge and weathering of the material, then if no replacement conducted, exposure of rod is likely to occur [27]. White powder or chalking and discoloration were visible on the upper side of the shed, figure 6 (b). This discoloration phenomenon happened because of the exposure of filler compound due to normal weathering [27]. The high precipitation in the area accelerated oxidative degradation, which leads to the intramolecular cyclization process [28]. On the other side, even though discoloration was minimally seen, the fungus contamination was observed. Also, as seen on figure 6 (c), the silicone grease on polymer insulator sheds on the bottom side existed and slightly more than the sheath and top surfaces. There were spotted crack on sheath parts likely near the energized end, but not on all over the insulator sheath. On both naturally aged insulators, no rod or core was exposed.

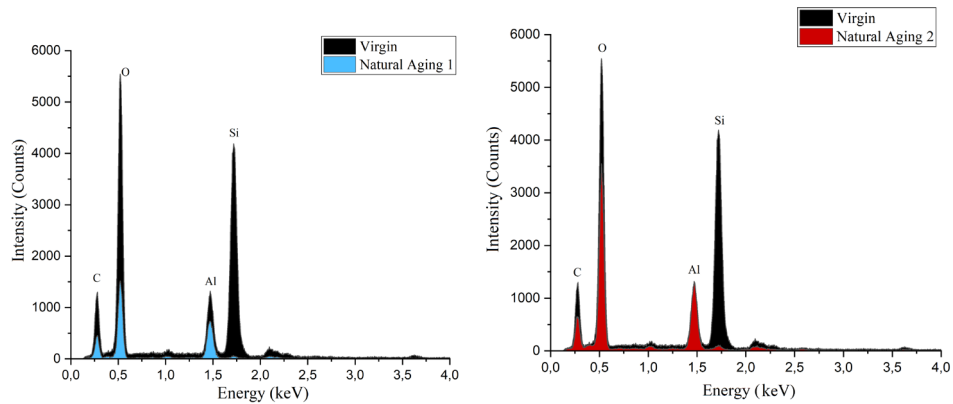
Figure 7. EDX result for virgin sample vs. natural aging sample

The EDX analysis had been performed for the virgin and natural aging samples. The results for natural aging-1 and natural aging-2 samples compared with virgin samples are presented in figure 7. The EDX graphs illustrate the peaks for carbon, oxygen, aluminum, and silicone.

The element-composition comparison between aged and virgin material was analyzed using EDX results, as shown in Table 5. The carbon and silicone components were decreased compared with the virgin sample

In contrast, oxygen and aluminum show an increased value. The ratio of aluminum to silicone, a vital parameter in EDX studies, is increased significantly. The silicone value decreased was caused by the thermal decomposition of the silicone rubber matrix and from the ATH filler of insulators. This condition showed a depolymerization occurrence. As seen in table 5, the virgin sample has 11.57 presentation of silicone component, and after aged for 30 years, the value decreased to 0.29% and 0.41% for natural aging-1 and natural aging-2 sample, respectively. This decreased condition agrees with the result of the FTIR analysis. The silicone chain breakdown indicates the fall of this silicone composition because of the photo-oxidation of UV radiation and the thermal effect of aging for a certain period. [37,46]. This condition showed a depolymerization occurrence. In silicone rubber, the silicone-oxygen bond could be broken due to the aging factor. The C/O ratio in the material composition was significantly decreased from 0.82% to 0.76% for Natural Aging-1 and 0.58% for Natural Aging-2. The increase of oxygen and decrease of carbon contents were proof of more extensive oxidation of surface material. The higher content of Al, which originated from ATH filler ( $\text{Al}(\text{OH})_3$ ), indicated the chalking on the surface material of the insulators, the increased filler concentration on its surface is related to the degradation of the main polymer component.

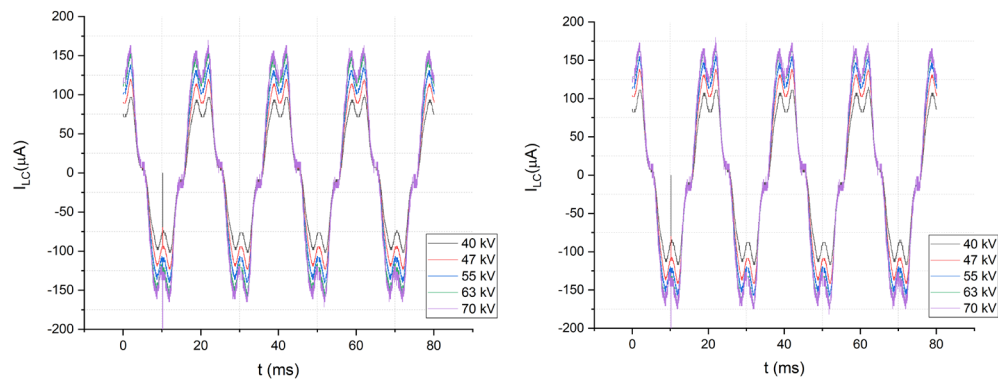
Figure 8. (a) The LC Waveform of Natural Aging-1 and (b) The LC Waveform of Natural Aging-2 Samples at Five Different Voltage Levels

The results of this leakage current measurement were shown in the waveform graph in figure 8, with the comparison chart of the leakage current magnitude in figure 9. Figure 8(a) for Natural Aging-1 sample and compared with figure 8(b) Natural Aging-2 sample, the NA-1 sample had a greater insulator resistance value than the NA-2 sample, which had a lower leakage current. Based on this graph, it could be seen that the 70 kV polymer insulator, which has been operating for 30 years in the field, had a leakage current range between 60-115  $\mu\text{A}$ . Due to this aging factor, it reduced the insulator's performance to withstand stress so that the leakage current increases.

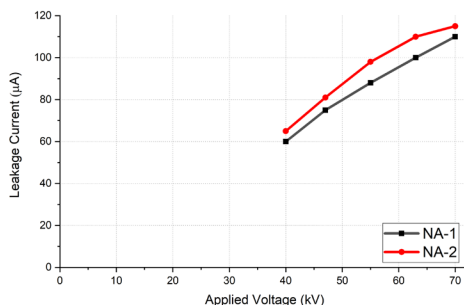
Figure 9. Dependence of Leakage Current on Applied Voltage

From figure 9, it can be concluded the NA1 had a smaller LC magnitude value compared with NA-2. Especially with the condition of the polymer insulator that had cracked, the tear in the housing had a lower resistance, so that the leakage current increased. This is due to the contribution of the insulator capacitance itself, non-linear resistance, and capacitance of pollutants, which can increase the magnitude of the leakage current flowing on the surface of the polymer insulator. The pollutant that traps water forms a conductive layer, so that larger LC flow occurred on the insulator surface. As a consequence of water molecules trapped on the insulator surface, the increase in the magnitude of LC may be caused by the increase in the conductivity of the insulator surface. If this continuously happens, continuous dry band is started forming which cause to discharge [26, 38].

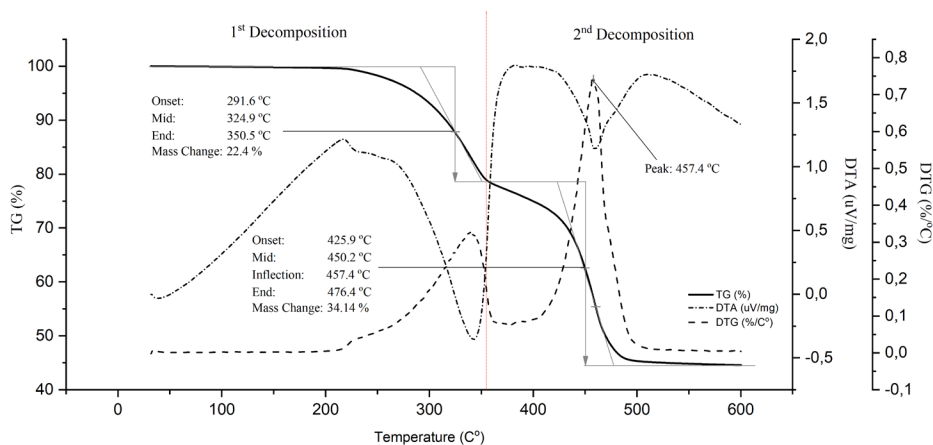
Figure 10. Thermogravimetric Graph for Virgin-1 Sample for 10°C/min Heat Rate

Thermogravimetric analysis was conducted to observe the effect of aging on the thermal stability and the thermal degradation behavior [37]. Figure 10 illustrates the results obtained from the TG/DTA measurement of virgin-1 sample at rate of 10 °C/min. The other three samples has the same typical thermogravimetric graph with virgin-1 sample. The TG plot has multistage decomposition. At the first inclination, the weight loss comprises volatile

components such as water and low-molecular-weight solvents. Then, for the second inclination or decomposition step, here occurs loss of massive weight of the main element; in polymeric insulator case, it is the filler. The percentage of mass change of first and second decomposition for virgin-1 sample were 22.4% and 34.14% respectively. From this plot, the onset and endpoint could also be gained. The onset point is a starting point where significant change occurs. Meanwhile, the inflection point is the peak maximum of the decomposition [39]. The onset points of first and second decomposition for virgin-1 samples were 296.3°C and 424°C, respectively.

In this thermogravimetric analysis, the experiments were done at three different heating rates of 10°C/min, 20°C/min, and 40°C/min. The results are seen in figure 10. The decomposition curves of DTG shift toward the higher temperature region with the increase of the heating rate. This is due to the reaction of temperature. The correlation is the higher reaction temperature, the higher reaction rate, hence the lower the oxygen's partial pressure at the gas-solid reaction interface and makes a new equilibrium of reaction. So that the rise in heating rate, the maximum weight loss rate is also increasing.

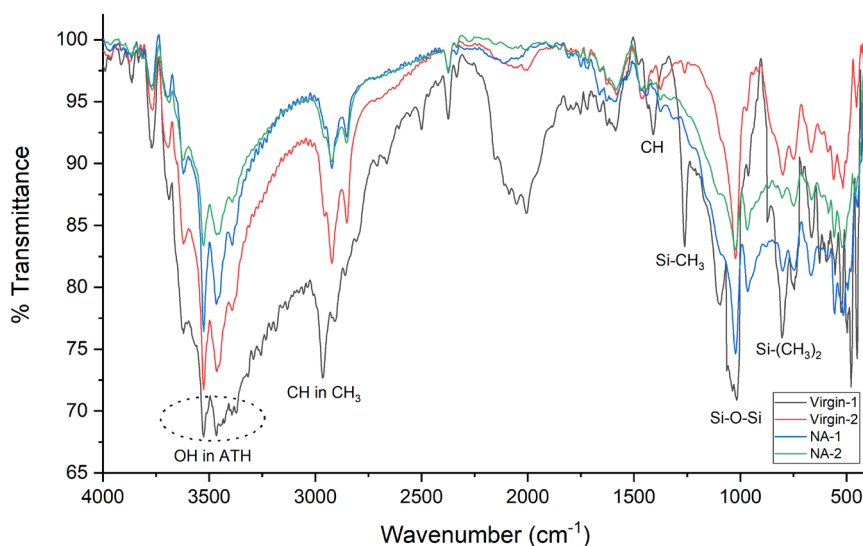
Figure 11. FTIR Transmittance Spectra of Four Different Samples

FTIR techniques can be applied to analyze the characterization of silicone rubber. The transmittance values are used for the characterization of the polymer and the filler. Figure 11 shows the FTIR spectra comparisons of the four samples at wavenumbers ranging from 500 to 4000  $\text{cm}^{-1}$ . The wavenumbers with significant bands and the corresponding functional groups are shown in Table 8. The concentration of the related bonds is proportional to the peak value of the FTIR transmittance bands. The reduced value of the peak heights of the chemical functional groups of virgin 2 sample and aged samples was caused by the weathering and aging factor [43-44]. From the figure 11, it could be observed that for all aged samples, the peaks of  $\text{Si}(\text{CH}_3)_2$  and  $\text{Si}-\text{CH}_3$  were decreased, which meant that the side chain was cut and the hydrophobic methyl group was fallen. Hence, this was the cause of the hydrophobic contact

angle for the aged sample was reduced. Furthermore, in the waveform at  $1000\sim1100\text{ cm}^{-1}$ , the functional group of Si-O-Si also decreased after being aged for 30 years. The fall of this composition indicated that the main chain of silicone rubber was broken, and the condition has been started to worsen deterioration conditions [45].

The reduction of the C-H stretching value for the aged sample was due to the photo-oxidation of UV radiation. So, the impact was the scission of  $\text{CH}_3$  bonds and the formation of carbonyl groups; this led to the reduction of surface hydrophobicity level [46]. The bond of O-H in ATH filler for natural aging-1 and natural aging-2 was decreased compared with the virgin sample. The downward peaks regarding these waveform numbers in the transmittance plot illustrated the broken bonds in ATH filler as it aged for an extended period. Moreover, the difference in peak value for natural aging-1 and natural aging-2 was 10% and 20%, respectively. These gave the same results with SEM and TG/DTA, in which the natural aging-2 had more severe conditions than the natural aging-1. This reduction was happened due to the association with the hydroxyl groups, the hydroxyl (OH) stretching of ATH filler [14].
